10. CYLINDER LINERS

10.0 Torn flange at cylinder liner

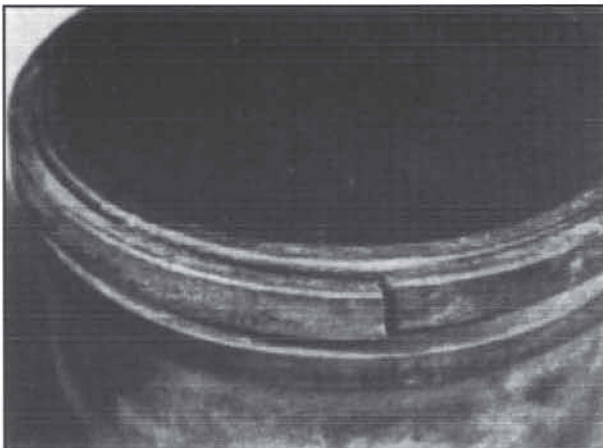
Picture 1

In the case of the cylinder liner, the complete liner flange is torn off, picture 1. The tear in the liner flange starts at the bottom of the lower edge of the liner flange and runs at an angle of about 30° transversely upwards.

The bending moments resulting from faulty assembly are responsible for this failure. In most cases, the cylinder liner flange is already compressed when the cylinder head is tightened. In order to avoid such defects during assembly, the following considerations must be taken into account:

1. No prescribed seals were used (cheap, copied gaskets are partially thinner or wrinkle more strongly).
2. The tightening torques and rotation angles prescribed by the engine manufacturer were not observed.
3. The storage of the liners in the engine block has not been carefully cleaned.
4. The alignment of the inserts was not tested for angularity and flatness.
5. The intersection of the flange face to the diameter of the fit to be soldered must be provided with a 0.5 - 1.0 millimetre x 45° phase to prevent seating.

- a) The transition of the flange face to the diameter of the flange seat shall be provided with an edge chamfer of 0,5 - 1,0 mm x 45° to prevent the hollow neck of the flange from seating when tightening the cylinder head.
- b) If the fit of the insert flange is wrong, then it must be turned over. This additional work is best carried out on a stationary drill or with a Mira, because only then is it possible to guarantee parallelism to the surface of the housing and thus also to stand the flange mounting surface vertically to the guide of the inserts.
